Piers 24 & 25 Marine Sediment Remediation Challenges and Solutions, Tacoma, Washington

Richard F. Moore (rick.moore@hartcrowser.com) and Gary E. Horvitz
(Hart Crowser, Seattle, Washington, USA)

Piers 24 & 25 Sediment Remediation Project

Lessons in Underpier Capping

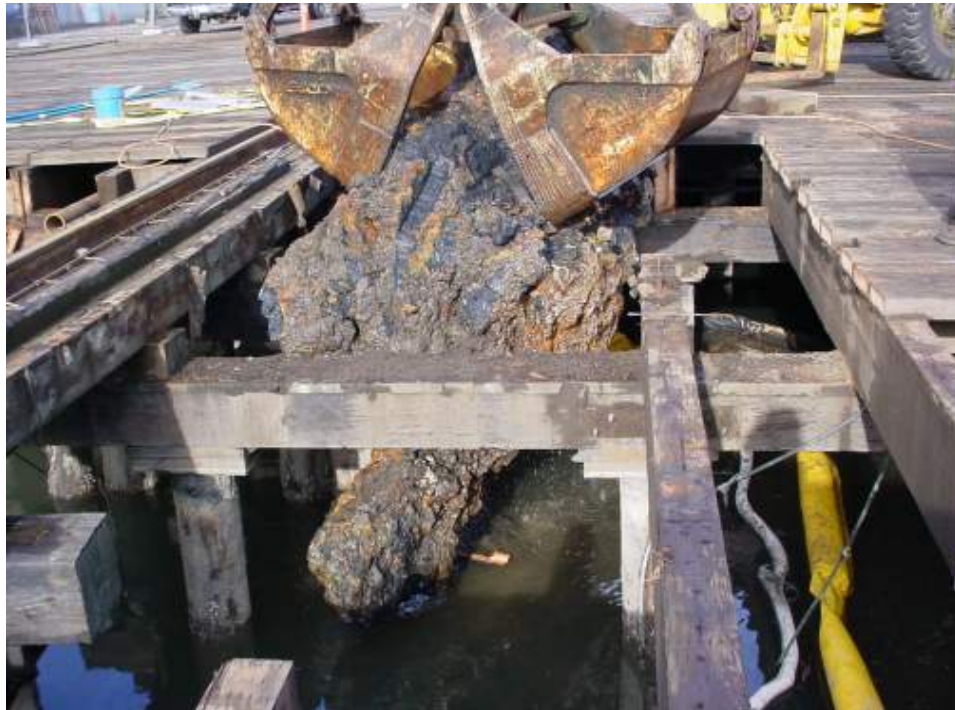
FIGURE 3. Metallic debris pile removal challenges.

Construction methods used for debris pile removal proved effective for excavating and extracting debris and leaving a relatively clean, even surface for subsequent slope capping. However, at one location between the site piers, deeper excavation to the original tideflat surface was necessary to capture fragmented debris that had sifted downward through underlying riprap. A long-reach excavator staged on the upland bank was used during low tide periods to complete excavation and backfilling. Although somewhat labor intensive, using the debris breakup and removal methods eliminated the need for more elaborate excavation and containment measures, particularly when accomplished in the dry.

Metallic-Debris Pile Removal. Metallic-debris piles consisting of more than 500 tons of amalgamated and indurated materials represented recognized contaminant sources in the aquatic environment. The presence of the debris piles also impeded embankment capping in the intertidal zone. Debris pile removal work was challenged by limited space in under-pier areas for staging the equipment and personnel needed to break the piles apart and transfer excavated material topside. Cross contamination of the nearshore environment and water quality impacts from potential loss of debris material during removal were additional concerns.

Debris pile removal proceeded by removing enough pier decking to maneuver machine-mounted impact breakers through the openings and break apart the debris piles remotely. In other areas, where access allowed and where larger equipment was not needed, personnel used jack hammers to manually break up debris piles. Loosened debris fragments were then carefully lifted through the deck openings in buckets or via clam-shell excavator (Figure 3). To manage the excavation and minimize downslope loss of material to marine waters, much of the debris removal was planned during low tide

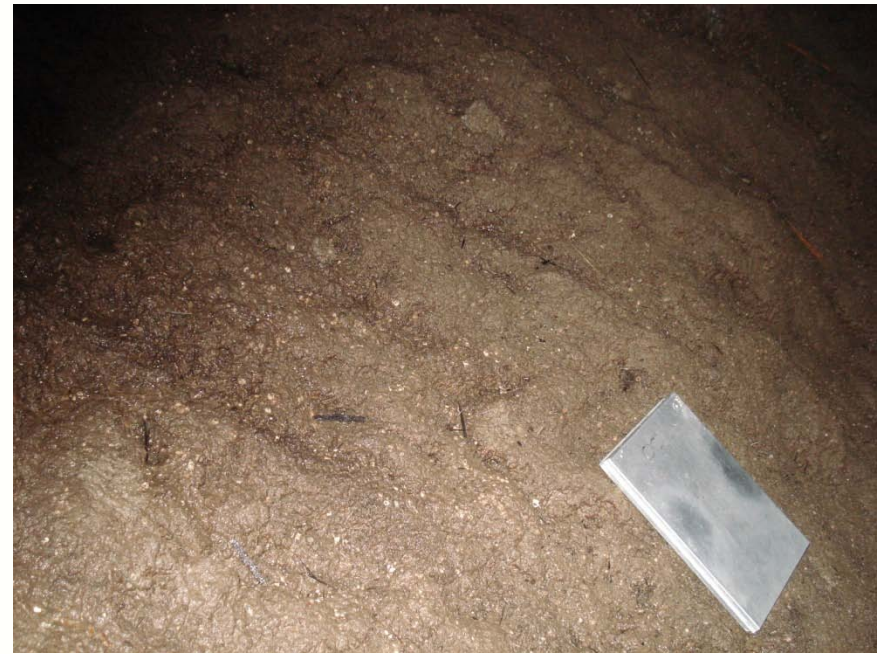
Armor Rock and Shotcrete – October 2010

- Piers 24 & 25 Cap Performing as Designed

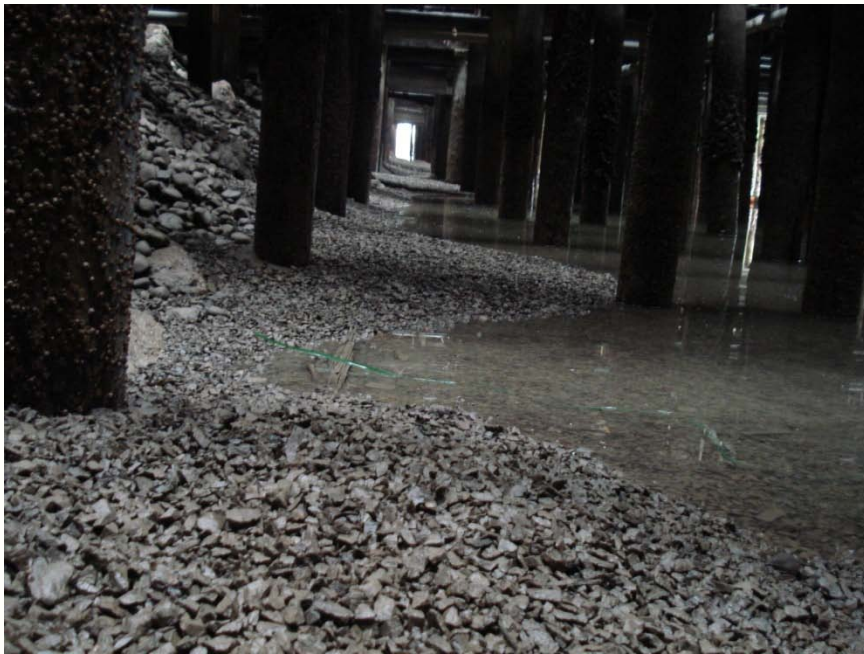
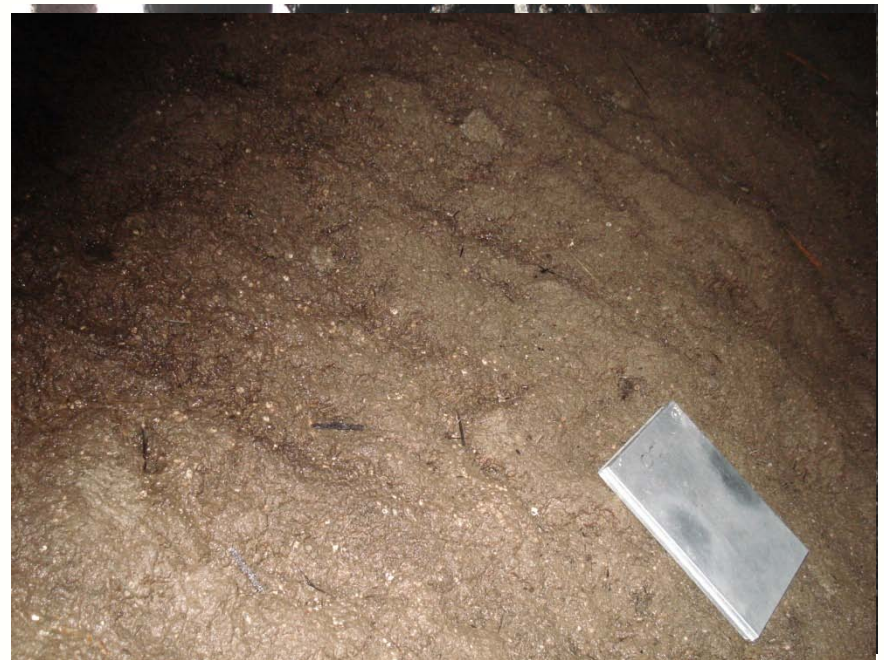
Armor Rock Cap Protection – October 2010

- Piers 24 & 25 Cap Performing as Designed
